**IN THE UNITED STATES DISTRICT COURT
FOR THE WESTERN DISTRICT OF WISCONSIN**

Case No. 3:19-cv-00602-wmc

DECLARATION OF IAN B. PATON

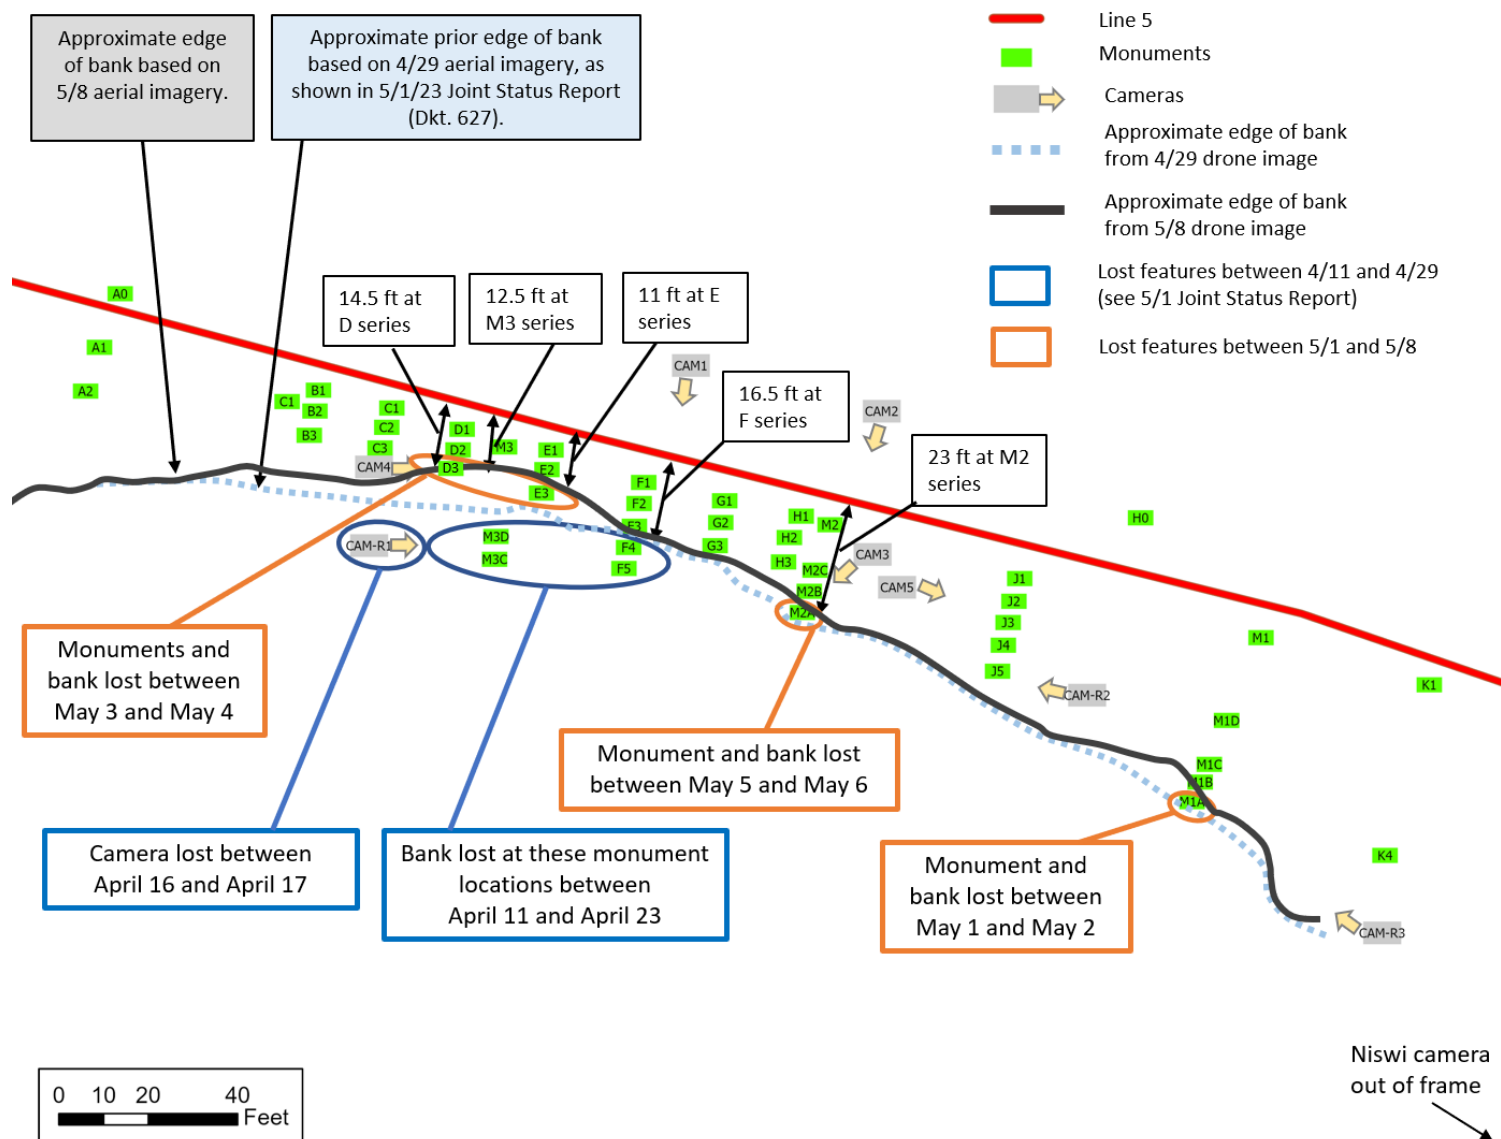
Figure 1. Schematic of monuments and distance from Line 5 to bank.

4. As of Monday, May 8, 2023, less than 15 feet remains between the the Line 5 pipeline and the top of the Bad River channel bank at four separate locations, listed in order from downstream to upstream (see Figure 1 and Figure 2), with all values rounded up to the nearest half foot):

- D series monuments: 14.5 feet
 - M3 series monuments: 12.5 feet
 - E series monuments: 11 feet

- Between the E and F series monuments: 13.5 feet
5. At the M3 monument series, the amount of channel bank currently remaining between the top of the bank and the Line 5 pipeline (approximately 12.5 feet) is just over 1 foot more than was lost in the 6 days between April 29 and May 5 (approximately 11 feet).
 6. The recently observed erosion has been distributed spatially across multiple series of monitoring monuments (see Figure 1), and at a number of those series has occurred at a rapid pace. The estimated remaining distance between Line 5 and the top of the channel bank for different dates in 2023 is summarized below for five locations, which are described in order from downstream to upstream along the neck of the meander:
 - a. D monument series:

Note: Monuments lost to bank erosion in April and May 2023 include Monument D3, M3C, M3D, E3, F4, F5, M2A, and M1A.

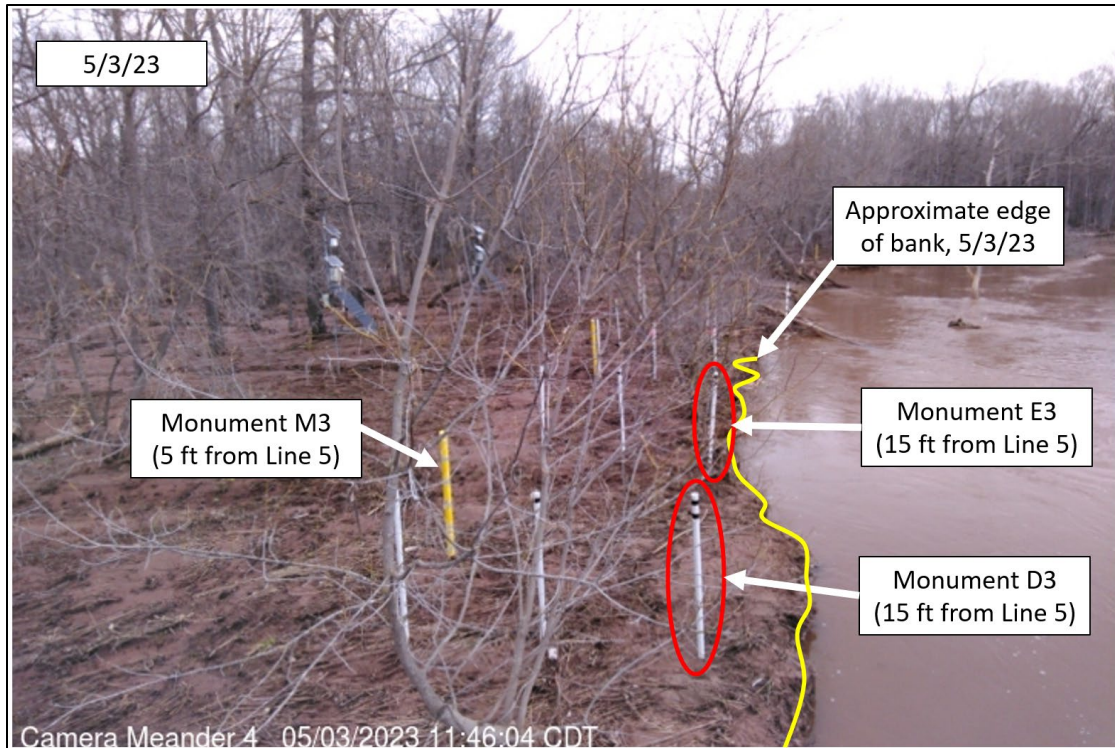
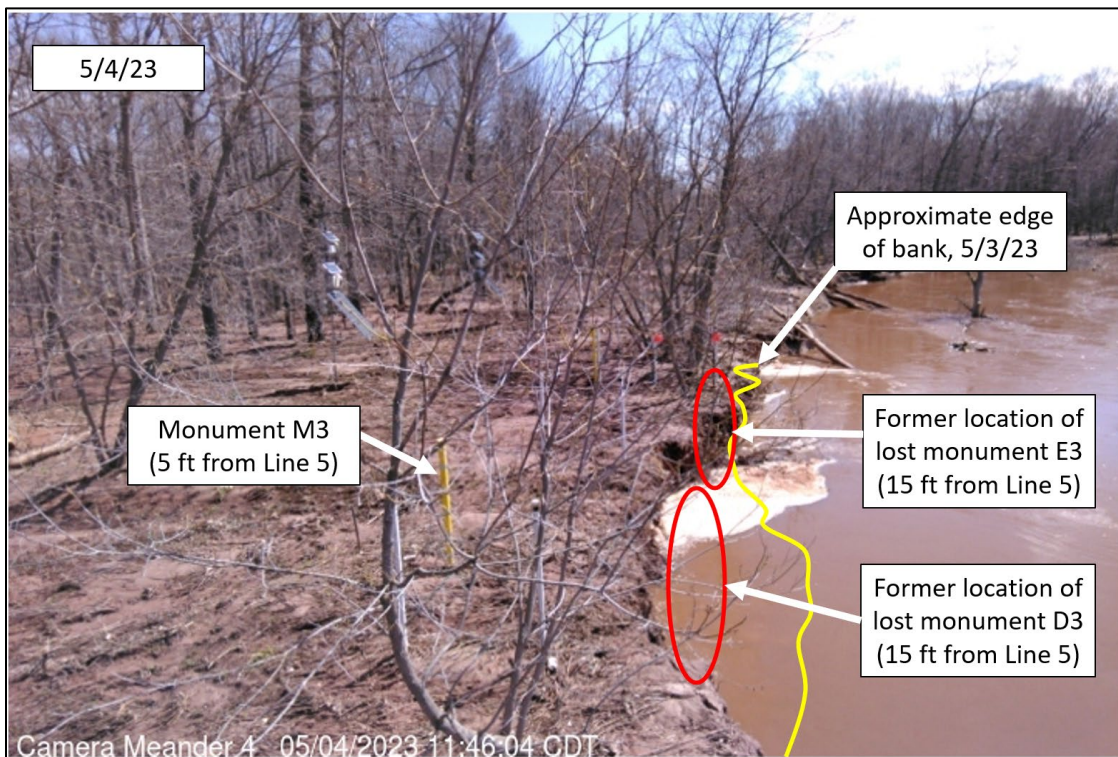
Figure 3. Comparison of Bad River bank in 24-hour period between May 3 and May 4, 2023 at D, M3, and E monument series.

7. The rate of erosion during April and the first week of May 2023 has been particularly rapid at certain places along the bank. For instance, in one 24-hour period, from May 3 to May 4, 2023, an estimated 3 to 4 feet of bank erosion occurred at both the D and E-series of monuments (see Figure 3). The highest flow rate in the Bad River during this time period, measured at the United States Geological Survey (USGS) gage 04027000 near Odanah, Wisconsin at Elmhoist Road (and adjusting for the distance to the meander neck) was approximately 6,000 cfs; that flow rate is less than a 2-year event and corresponds with the rate when flow begins to spill out of the Bad River's main channel and through overflow channels across the meander neck as described in WWE's affirmative report (Section 3.2.2.2, page 76). (Note: All subsequent references in this declaration to USGS flow measurement data are for this gage).

- d. In addition to the possibility of a major flood event (such as a 100-year event) with significant associated erosion, smaller flows can also cause significant erosion. This has been observed recently, with an estimated 3 to 4 feet of bank loss at the D and E monument series in one day (see Figure 3) occurring when the flow in the Bad River was approximately 6,000 cfs, which is less than a 2-year event. In April 2020, 5 feet of erosion was observed in a one-week period associated with a flow event that had a peak flow less than 8,000 cfs (approximately a 2-year event) as described in Section 3.3.8.1 of WWE's January 2022 affirmative report.

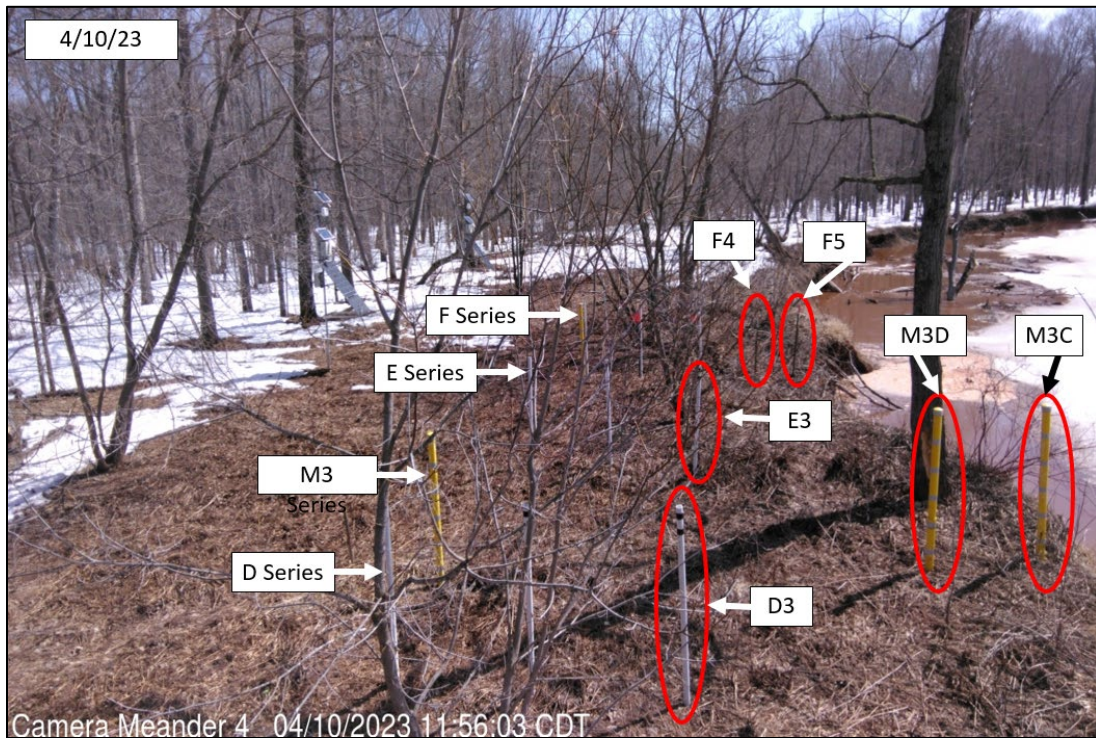
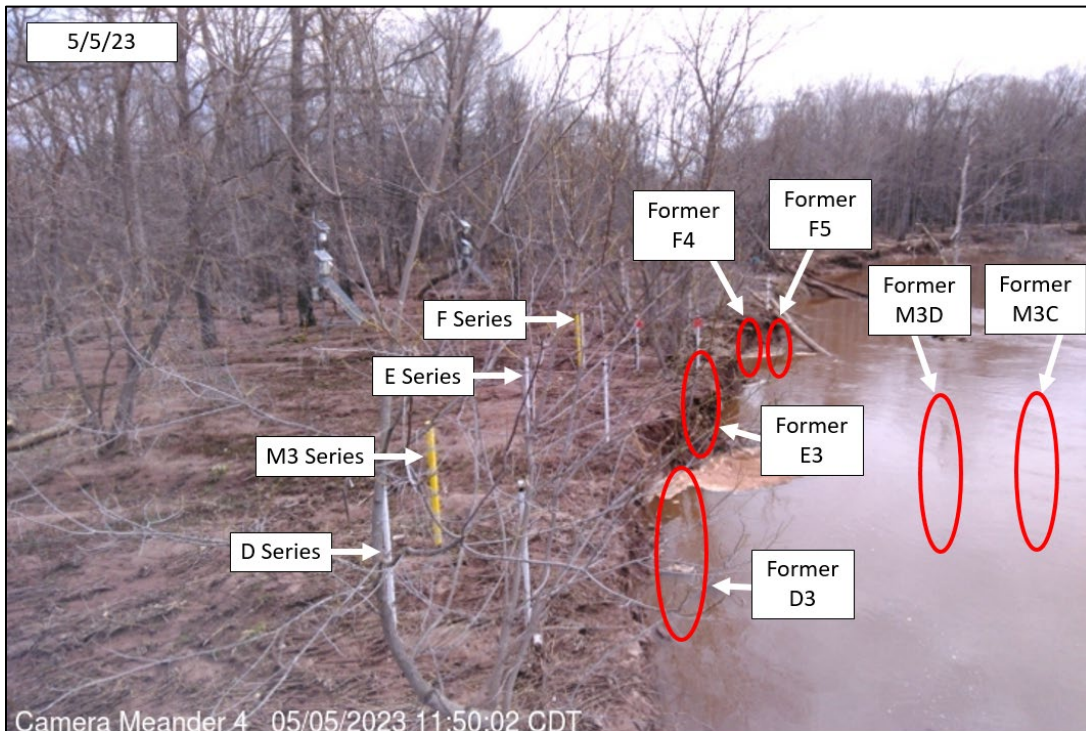
Figure 4. Comparison of Bad River channel bank between April 10 and May 5, 2023 at D, M3, E, and F monument series.

10. In addition to the loss of soil, the erosion has resulted in the loss of a monitoring camera owned by the Band (shown as “CAM-R1” on Figure 1, located downstream from the M3 monument series). Another of the Band’s monitoring cameras was moved to prevent it from being lost to erosion. Enbridge Camera 4 (used to observe an area with active bank erosion as shown on Figure 3 and Figure 4) was approximately 4 feet from the top of the channel bank as of May 5, 2023; this is

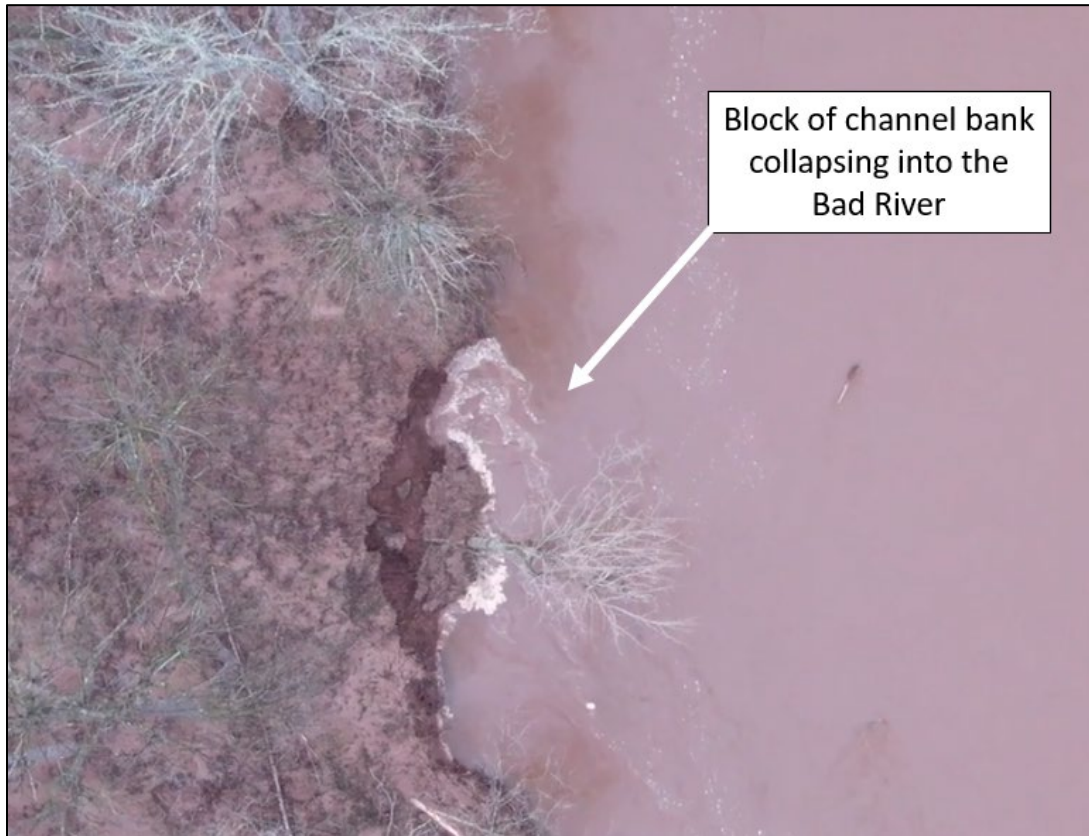
8. The recent erosion has left large segments of the channel bank in an unstable condition. An image clipped from drone video collected on May 6, 2023 shows a block of channel bank with a tree collapsing into the Bad River immediately downstream from the narrowest portion of the meander neck (see Figure 5). This bank failure occurred while the flow rate in the river was less than 4,000 cfs, measured at the USGS gage, or between a 1- to 2-year event.

Figure 5. Drone image from May 6, 2023 of tree with channel bank collapsing into the river.

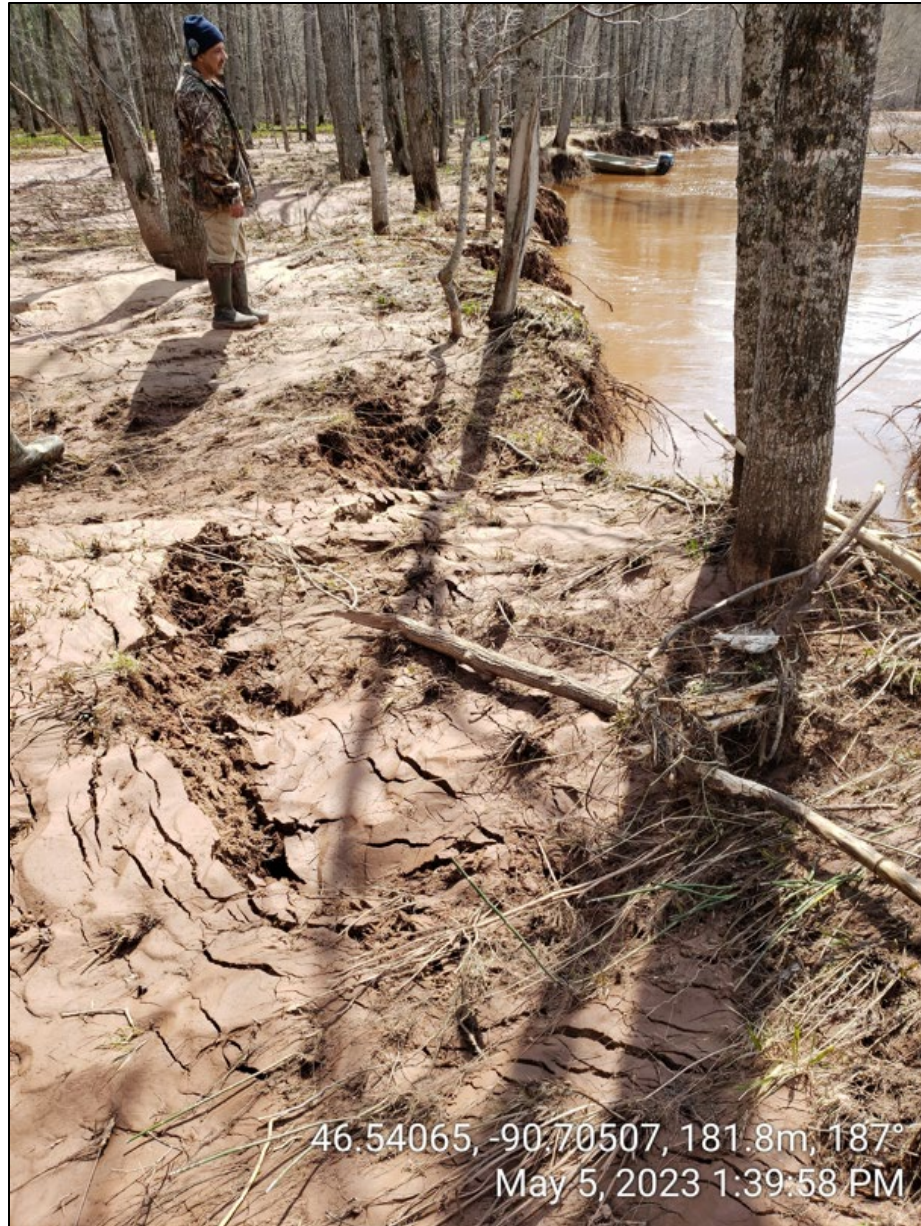
9. Photographs taken by the Band's Natural Resources Department during a May 5 field visit to the meander show cracks in the channel bank that indicate locations where the bank is more susceptible to large slope failures into the river (see Figure 6).

Figure 6. Photograph of cracks in channel bank at upstream end of meander neck taken on May 5, 2023.

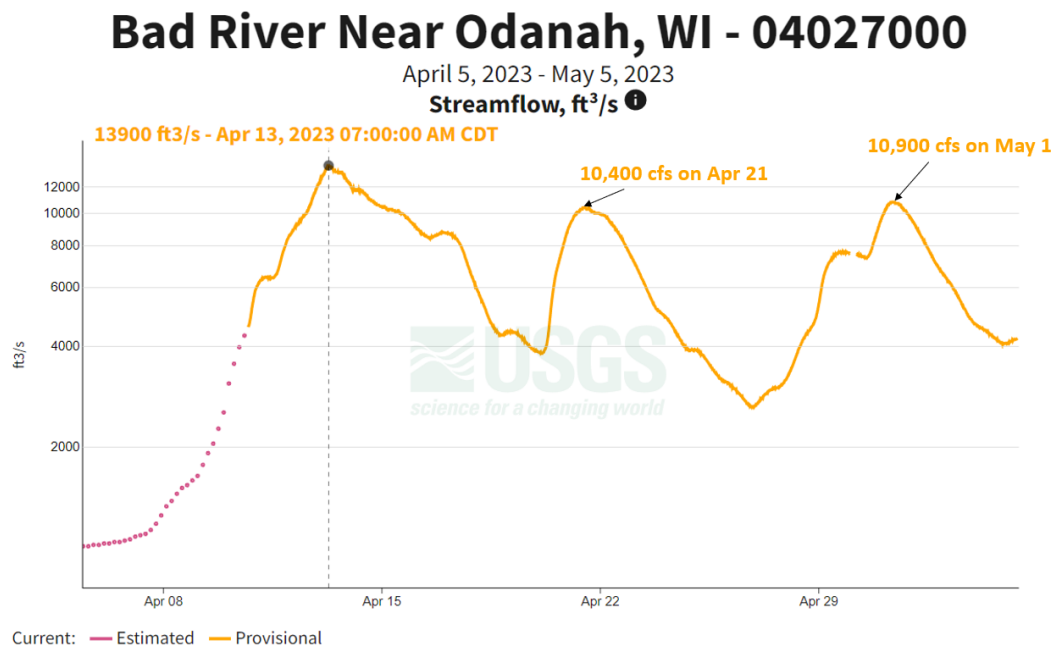
11. The erosion observed during the past month was caused by elevated flows in the Bad River as a result of snowmelt and rainfall in the watershed. The flow rates from April 5 to May 5 measured at the USGS gage are shown on a hydrograph (see Figure 7).

12. The peak flow rates from April 5 to May 5, 2023, as measured at the USGS gage and shown on Figure 7 are:
 - 13,900 cubic feet per second (cfs) on April 13, 2023
(less than the 10-year event calculated value of 14,800 cfs; meaning there is a more than 10 percent probability of occurrence each year)

- 10,400 cubic feet per second (cfs) on April 21, 2023
(less than the 5-year event calculated value of 11,600 cfs; meaning there is a more than 20 percent probability of occurrence each year)

- 10,900 cubic feet per second (cfs) on May 1, 2023
(less than the 5-year event calculated value of 11,600 cfs; meaning there is a more than 20 percent probability of occurrence each year).

Figure 7. Hydrograph of Flows in the Bad River from April 5-May 5, 2023

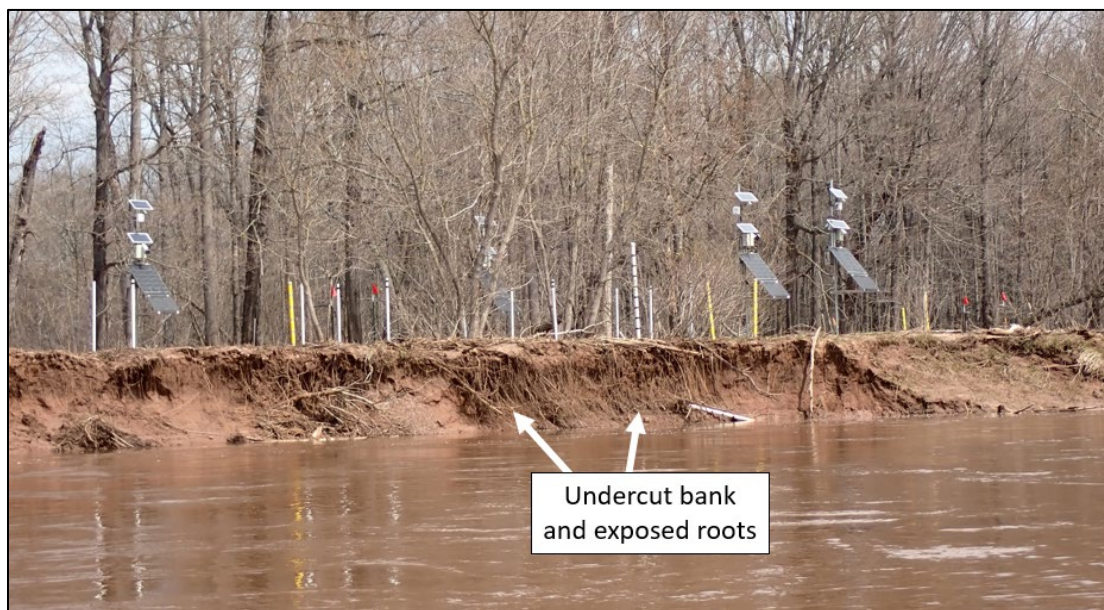
- a. Based on review of ground camera imagery and aerial drone videos, undercut sections of the bank presently exist. There are also undercut areas where roots are visible and exposed (Figure 8). Undercut areas are prone to collapse and bank loss. If large vegetation with exposed roots loses support and falls into the river, several feet of bank can be lost. Such an event was recorded by a drone while it was occurring on May 6, 2023 (see Figure 5) and has also been observed previously at the Bad River meander (see Figure 9).

Figure 8. Photo from May 8 showing undercut bank and overhanging roots.

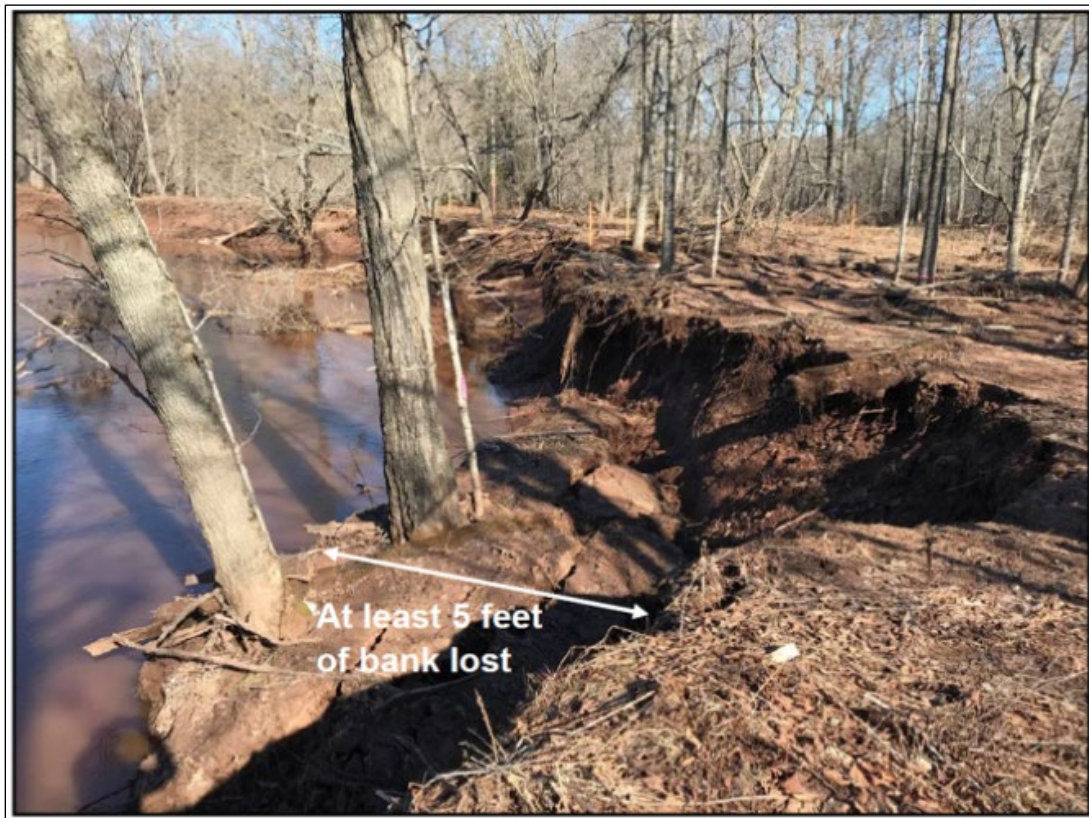
Figure 9. Example of bank loss caused by trees falling into river, April 16, 2019, from WWE's January 2022 affirmative report, Appendix O.
